**SAS Superstructure**

Location: 04-SF-80-13.2 / 13.9

**Daily Diary Report by Bid Item**

**04-0120F4  
04-SF-80-13.2/13.9  
Self-Anchored  
Suspension Bridge****Weather**

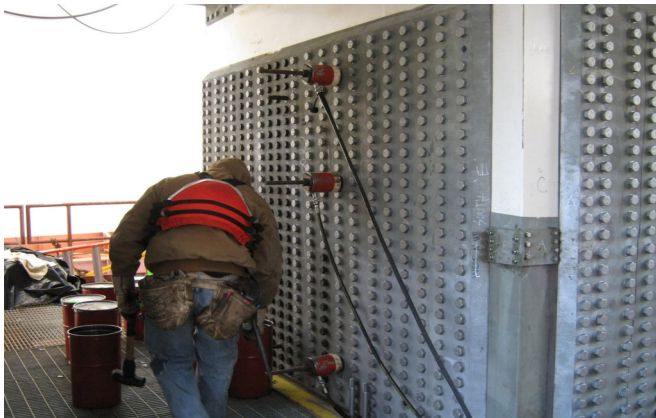
Installation of bolts was ongoing today at Splice #1, South shaft, Skin plates. Prior to snugging the bolts, bottle jacks with a rod through several bolts holes were used to bring the plies into firm contact (see attached photo). Below is a list of the locations where each RoCap set number was installed.

Jacks being used to bring splice plate plies into firm contact
